Repair and Replacement of Hunter Cabin Roof And Log House Porch Repair

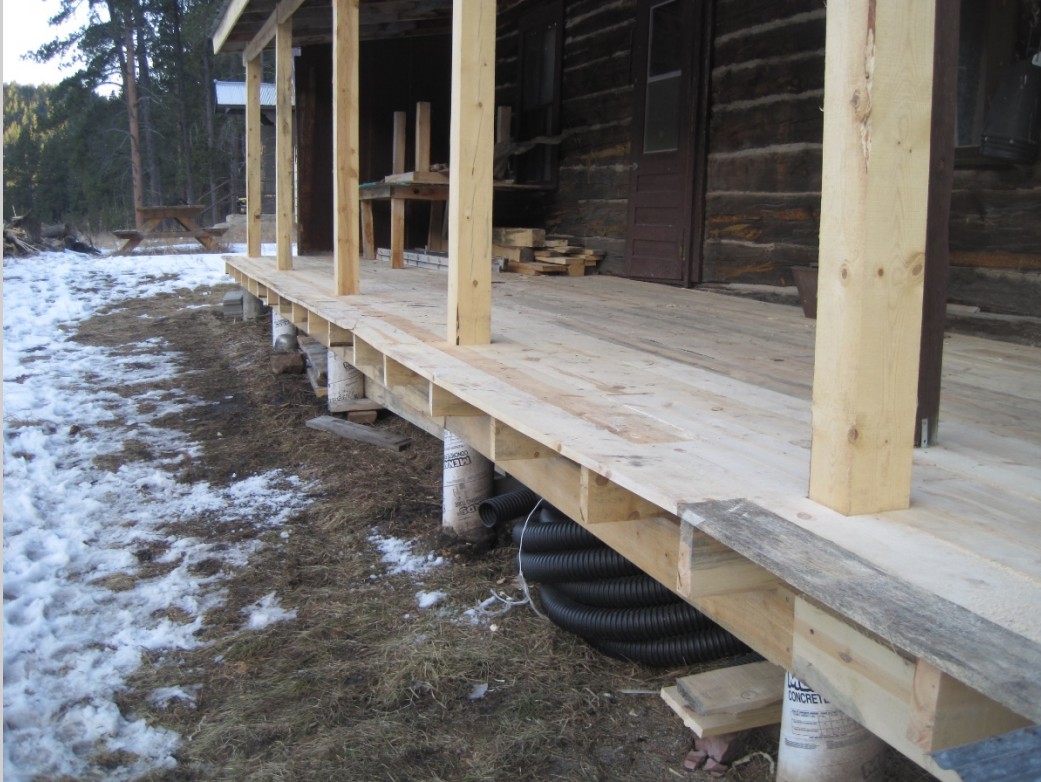
Photo E. The porch on the historic log house was reconstructed on the west side to remove its weight from the log wall, now resting on its own foundation. The south side was repaired. The lumber is rough sawn to be like the original. Logs were skidded to sawmill, cut into lumber and hauled to the site.

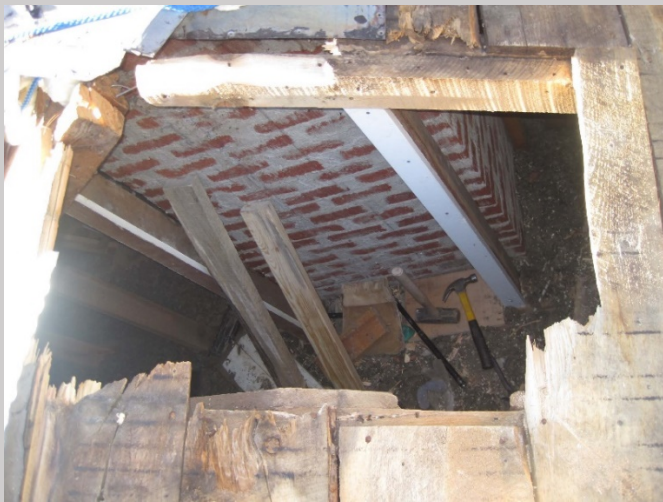
Photo A. The historic Hunter's cabin or north cabin had developed leaks in the roof causing water damage inside. In Winter/Spring of 2016, high winds blew dead bug trees onto the roof which caused structural damage.

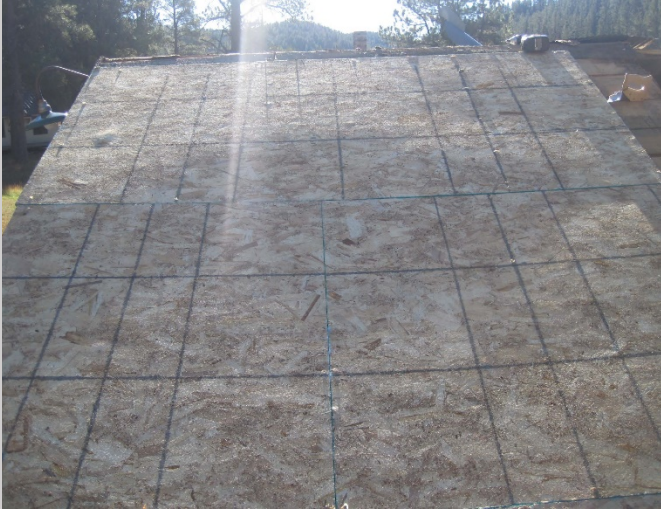
Photo B. With the structural damage to the rafters and chimney repaired, the roof was resurfaced with 4X8 sheets of OSB.

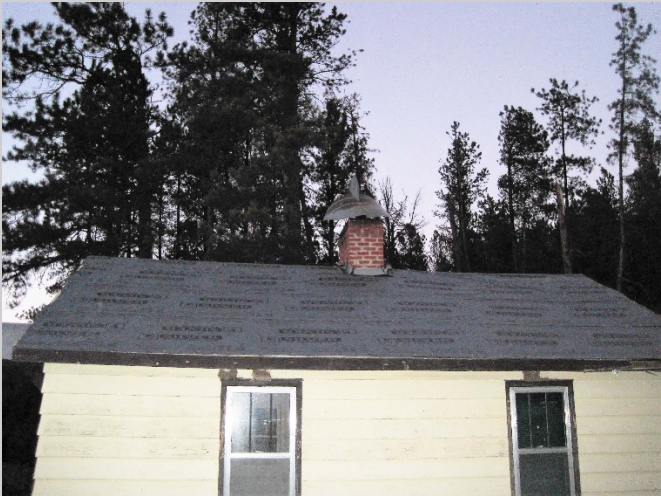
Photo C. With a new stronger subroof, a water tight barrier was applied as an underlayment before installing the metal roof.

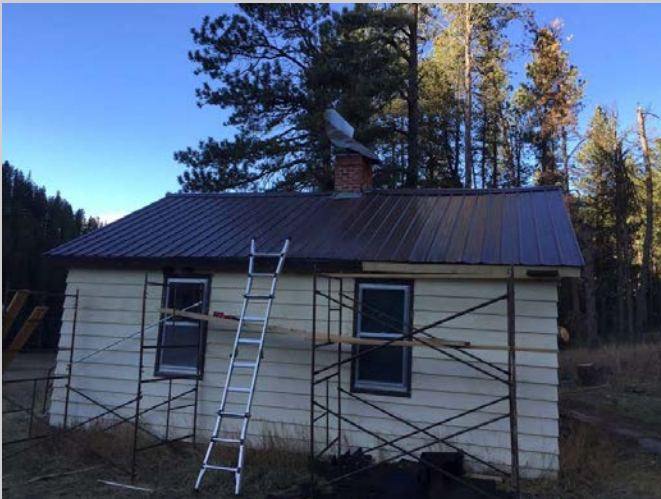
Photo D. The new ProRib roof was installed in November of 2016. The roof is a dark brown color to match the color and design of the old historic log house.
